Oil whip of a rotor supported in a poorly lubricated bearing

by Agnes Muszynska, Ph.D.
Research Manager
and Senior Research Scientist
Bently Rotor Dynamics
Research Corporation
agnes@bently.com

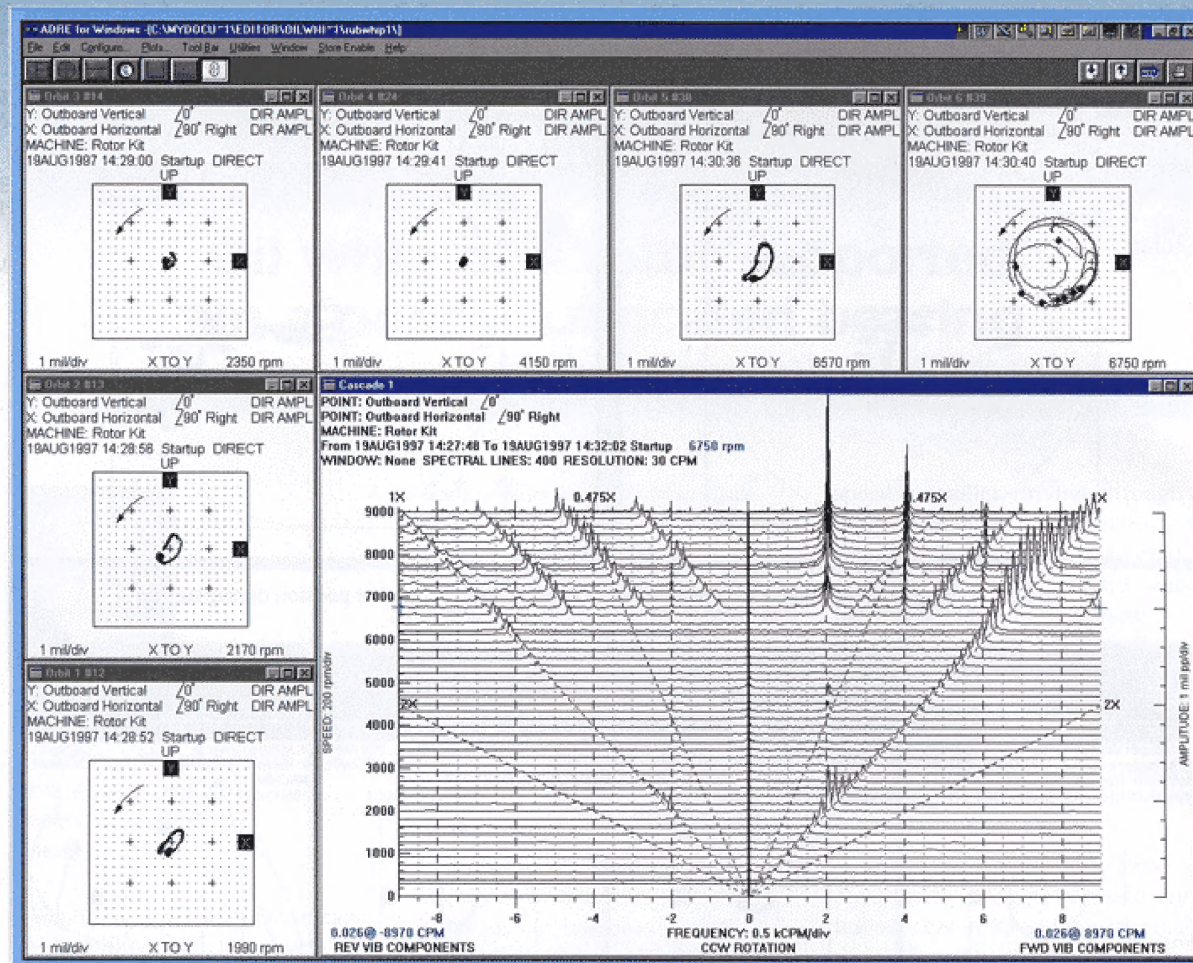
Figure 4 - Full spectrum cascade plot of the journal lateral vibrations during startup, with selected orbits.

The full spectrum cascades (Figures 3 and 4) present the midspan and journal startup vibrations. The rotor is stable, exhibiting low-magnitude, elliptical 1X orbits until approximately 3800 rpm, when small, oil whip-type, self-excited vibrations occur (see rotor orbit at 4150 rpm, Figure 3). This speed is the rotor's natural frequency doubled (or rather, it is the $1/\lambda$ multiple of the natural frequency; λ = fluid circumferential average

nal orbits at 6750 rpm, Figures 3 and 4). The journal orbit envelope is circular and nearly equal in magnitude to the bearing clearance; the midspan orbit is elliptical (due to an anisotropy of the rotor supports), and exceeds 40 mils pp. The rotor is dramatically vibrating at its first bending mode.

The full spectrum cascade plot confirms the ellipticity of the rotor mid-span whip orbit (31 mils pp of the forward component and 8 mils pp of the backward one), and the almost circular orbit of the journal (the reverse component is only approximately 0.5 mils pp, while the forward one is 9 mils pp).

major vibration components in the spectrum (1X due to rotor unbalance and the oil whip vibrations). Due to nonlinearity of the system, they create sideband sum/difference components. Note that the whip frequency, which was 2000 cpm at the instability threshold, slightly increases at higher rotative speed: to 2010 cpm at 7290 rpm and to 2030 cpm at 7740 rpm and higher speeds. This

effect is best seen on the third harmonic of the whip (Figure 4).

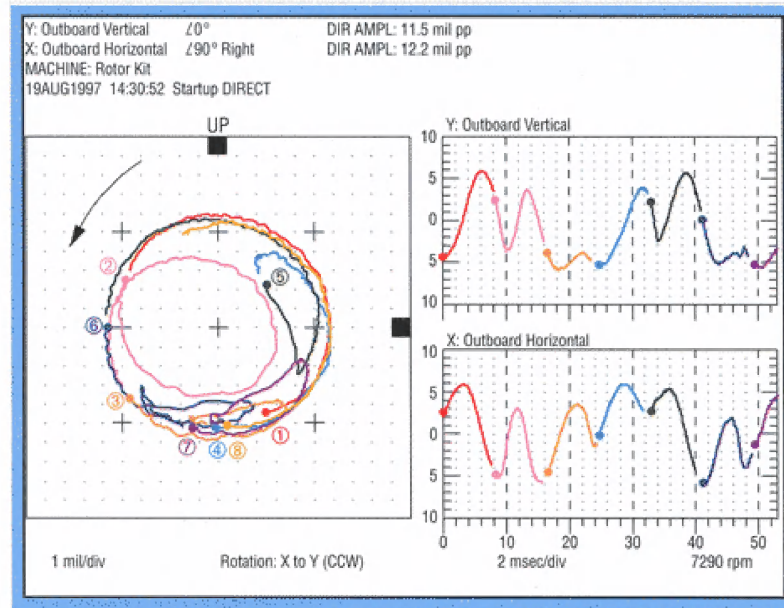
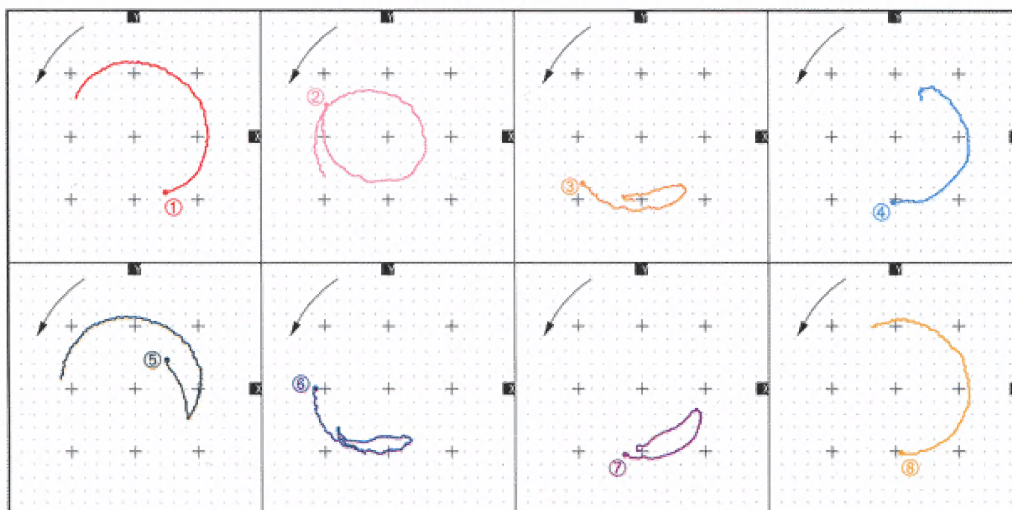
Figure 5 - Journal orbit and timebase waveforms at 7290 rpm.

Figure 5-1. Orbits of the eight consecutive rotations of journal shown in Figure 5.
Keyphasor dot marks start of orbit.

The richness of the spectrum is due to the unusual behavior of the fluid film in the outboard bearing. The low-input pressure of the oil creates oil starvation and entrainment of air. Thus, the oil wedge produced by fully developed circumferential flow due to journal friction drag of the lubricant is no longer uniform. The voids allow the journal to experience more direct contact with the bearing surface. In this situation, which is similar to a rub, the flow-related forward-driving tangential force is occasionally replaced by a contact-friction-related backward driving force in the air voids. The tangential force becomes highly variable, from forward to possibly backward directions. When the journal/bearing contact occurs, the rotor forward precession may stop, then reverse for a short while until the pressure wedge sufficiently builds up, pushing the journal in the forward direction again. The result of this action is seen on the journal orbits (Figures 5 and 6). The numbers on the Keyphasor® dots indicate consecutive rotation periods of the rotor.

During the first rotation (Figure 5-1), the high amplitude vibrations are classic for the oil whip. During the next rotation, however, the journal makes an internal loop, as the whip amplitude decreases. During the third rotation, the journal reverses and makes a small loop. It continues forward for a while, then reverses again in three slightly larger loops, before reaching the eighth Keyphasor dot.

At the end of the fourth rotation, just before the fifth Keyphasor dot, the forward, oil-whip characteristic orbit reverses, and the journal makes a detour, for a short while going backward (approximately 1/4 of the rotation period), then recovers (the oil wedge succeeds in building up)

The journal reversing for rotations 3, 6, and 7 occurs in the lower right quadrant, the same quadrant where the rotor centerline was at high eccentricity, thus in the area where the journal/bearing contact occurs. From the character of the orbital motion, it looks like when an oil void occurs, it causes the rotor forward precessional motion to stop and reverse by giving it a reverse impulse. At that moment, however, the journal moves away from the bearing surface, so that oil film has a chance to build up again. This scenario repeats four times within 5 rotations (Figure 5).

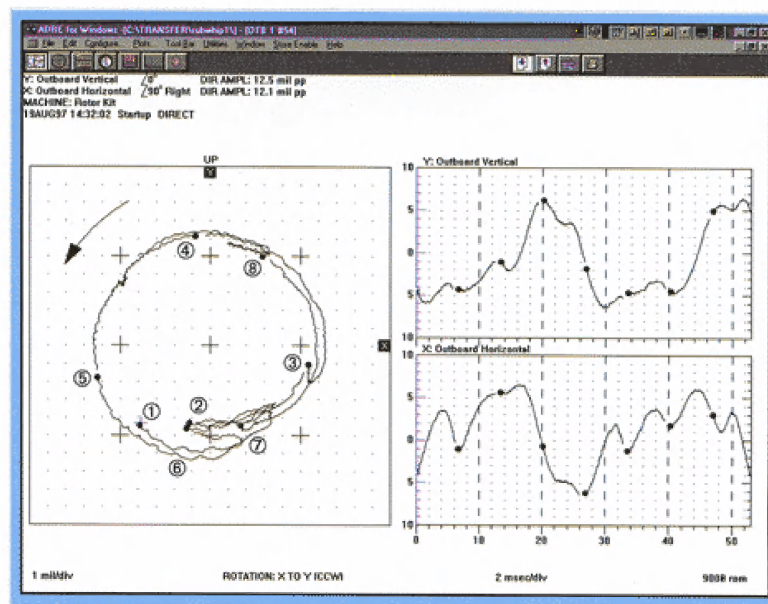
Figure 6 - Journal orbit and timebase waveforms at 9008 rpm.

At high speed, the journal orbit is much smoother; several smaller backward loops still appear (Figure 6). The higher speed provides a larger energy into the forward motion, thus the backward impulses from the surface contacts are relatively smaller [5].
